Mission to the Area Affected by the Earthquakes in the Pianura Emiliana-Padana of May-June 2012

Brief Note

Report EUR 25467 EN/1

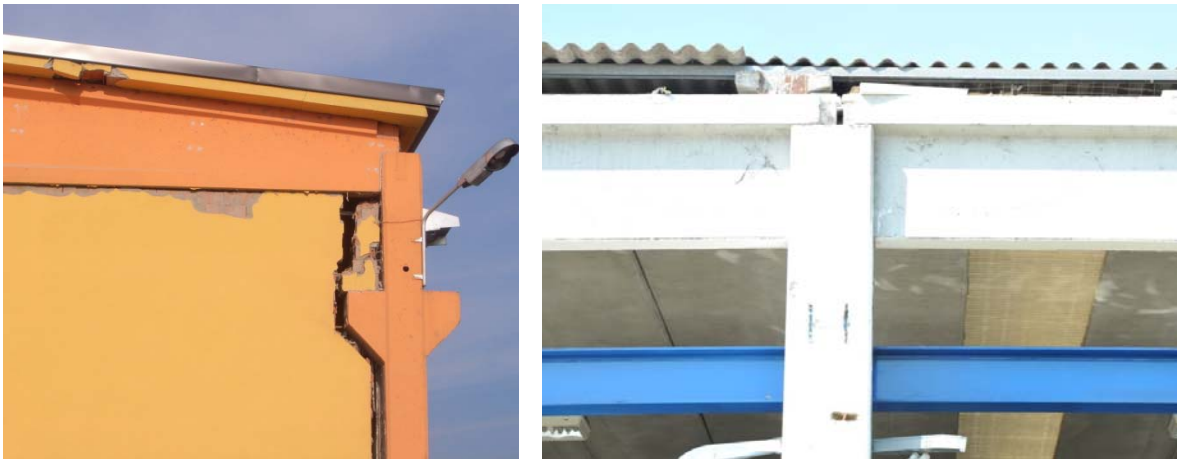
Figure 2: Seating of precast beams in the columns' forks

- Most precast buildings were designed and constructed before 2003 (plus grace period and permission filing): designed for gravity loads, beam-to-column joints with no connections capable of transferring horizontal loads and insufficient sitting, isolated column foundations.
- Few buildings designed during the last 5-7 years (i.e., with seismic provisions), the majority found in Mirandola, Concordia sulla Secchia and Novi di Modena.

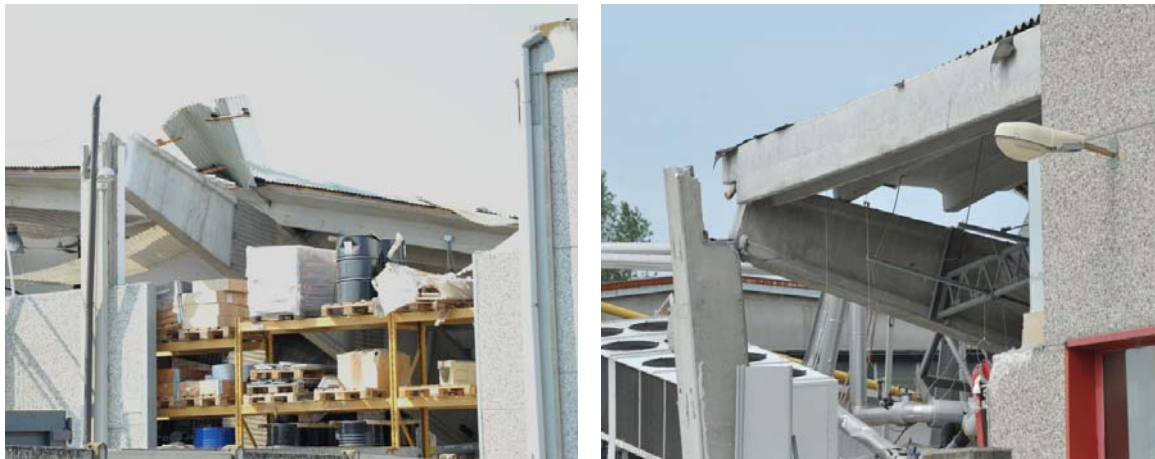
Figure 3: Loss of beam seating from central column and collapse.

- For precast industrial buildings designed with non-seismic provisions in the affected area: 75% presented damage and detachment of the exterior cladding, with 25% presenting partial or total collapse of the roof and girders (due to un-sitting of the main girder). *Note: values are estimated from the observations.*

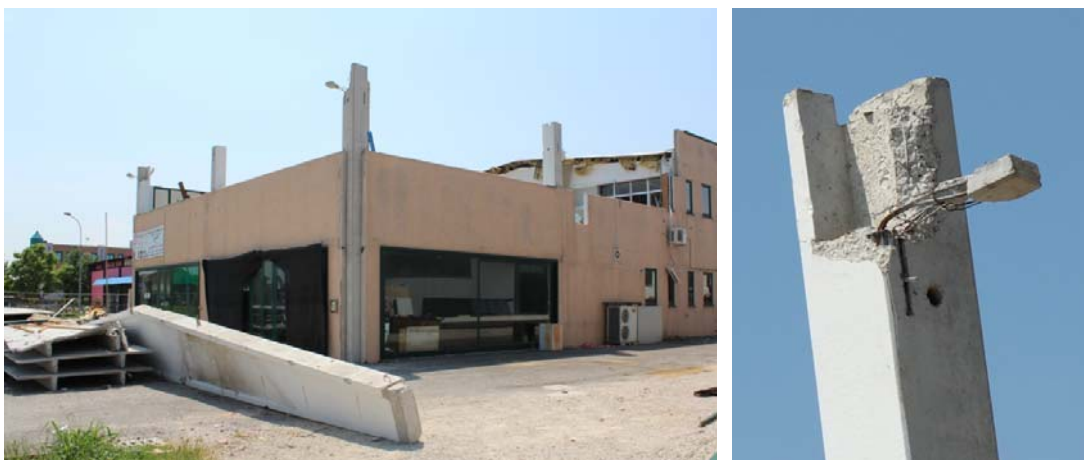
Figure 4: (a) Out-of-plane unseating of the girder. (b) Shear rupture of a column fork

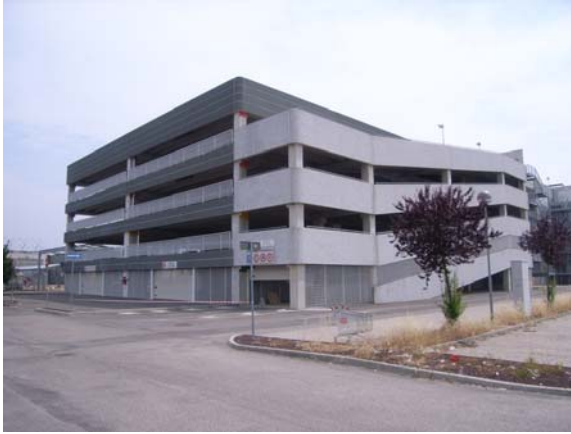
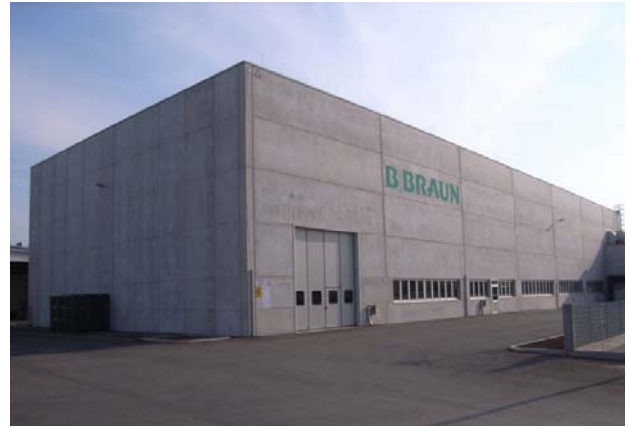
Figure 5: Modern precast concrete building which exhibited good performance during the earthquake events of May 2012

- The collapse of cladding was due to insufficient capacity (strength or ductility) of the connections.
- For precast industrial buildings designed with seismic provisions in the affected area: no damage of the main structure or cladding, with the exception of one building that presented partial collapse.
